# User Guide

Gateshead mine water heat living laboratory  
dataset

January 2025

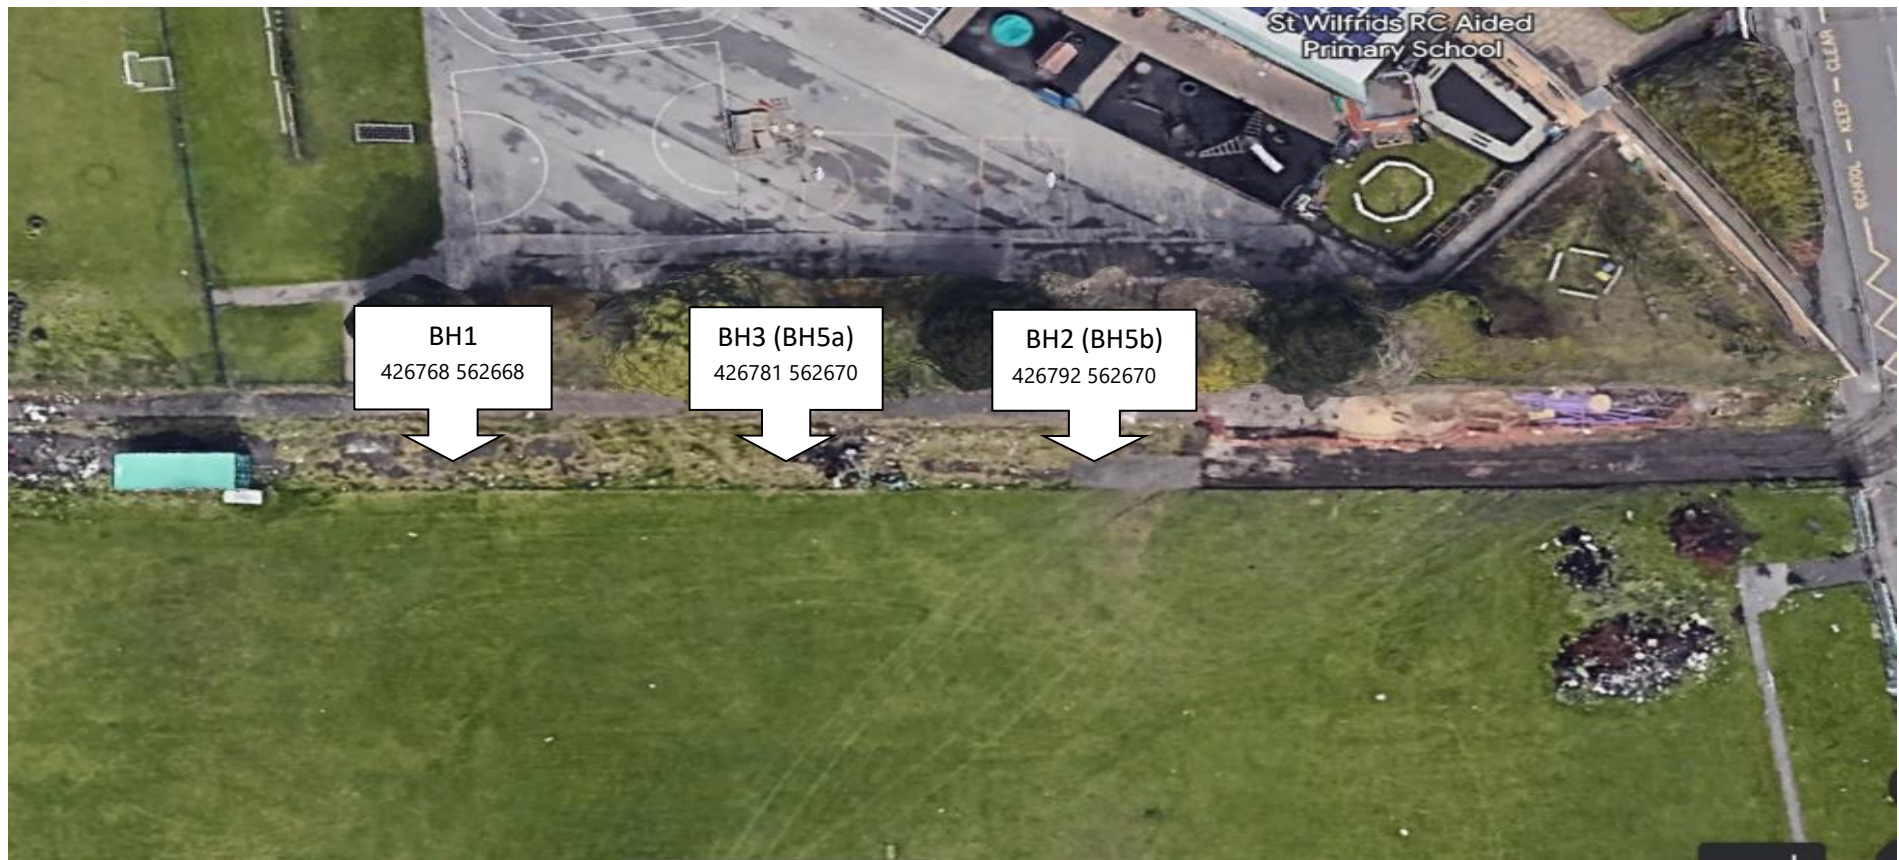
**Fig. 1: Aerial view of site A5, Gateshead living labs, and locations of BH1, BH2 (BH5b) and BH3 (BH5a)**

Grid reference:

- BH1: 426768 562668
- BH2 (BH5b): 426792 562670
- BH3 (BH5a): 426781 562670

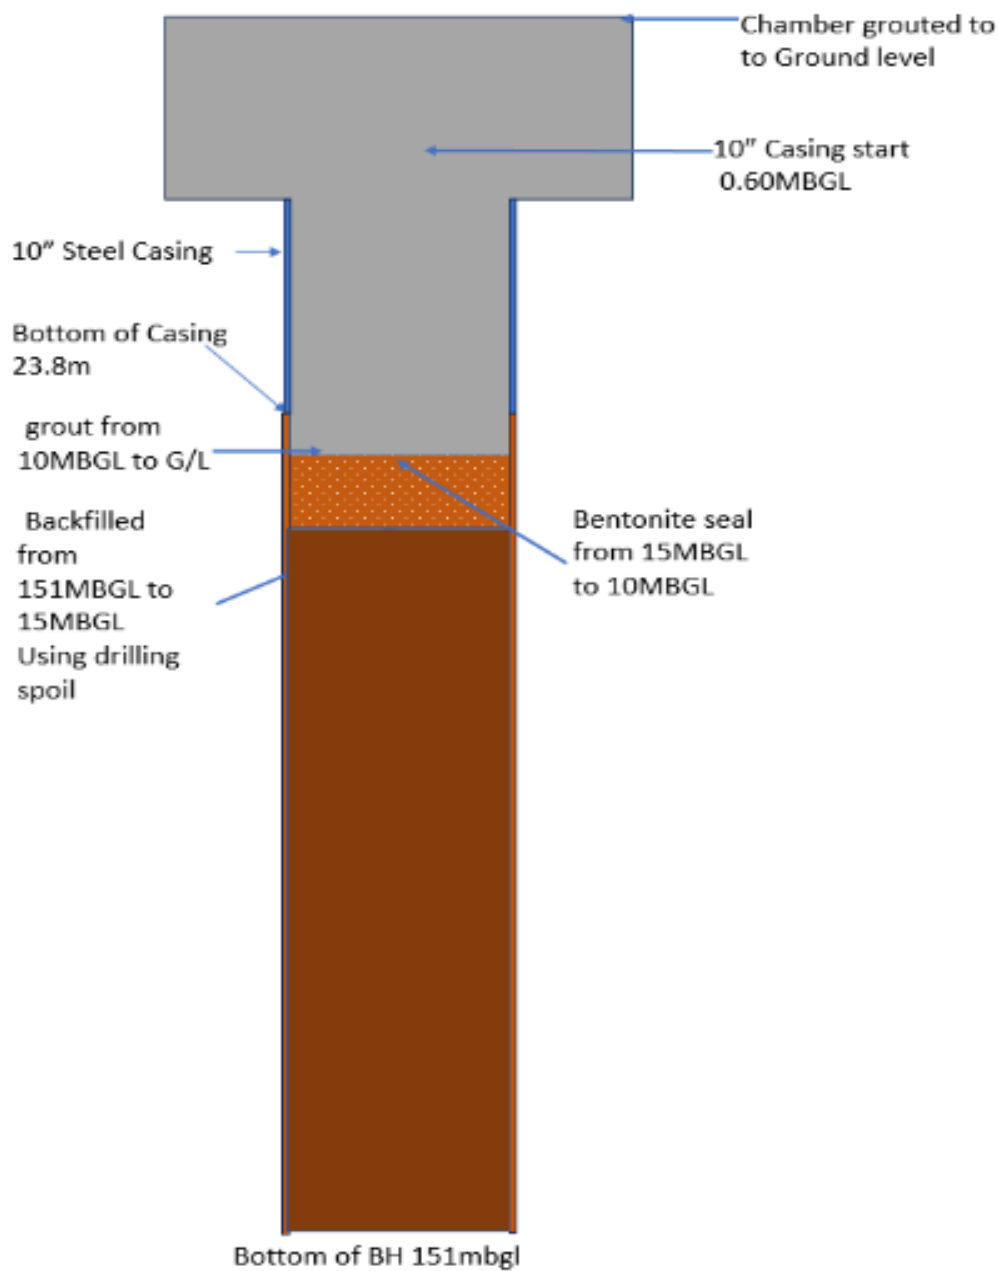
### Site A5, (Gateshead living lab) Borehole 1 diagram.

**Fig. 2: Diagram of BH1 decommissioning performed in June-2023**

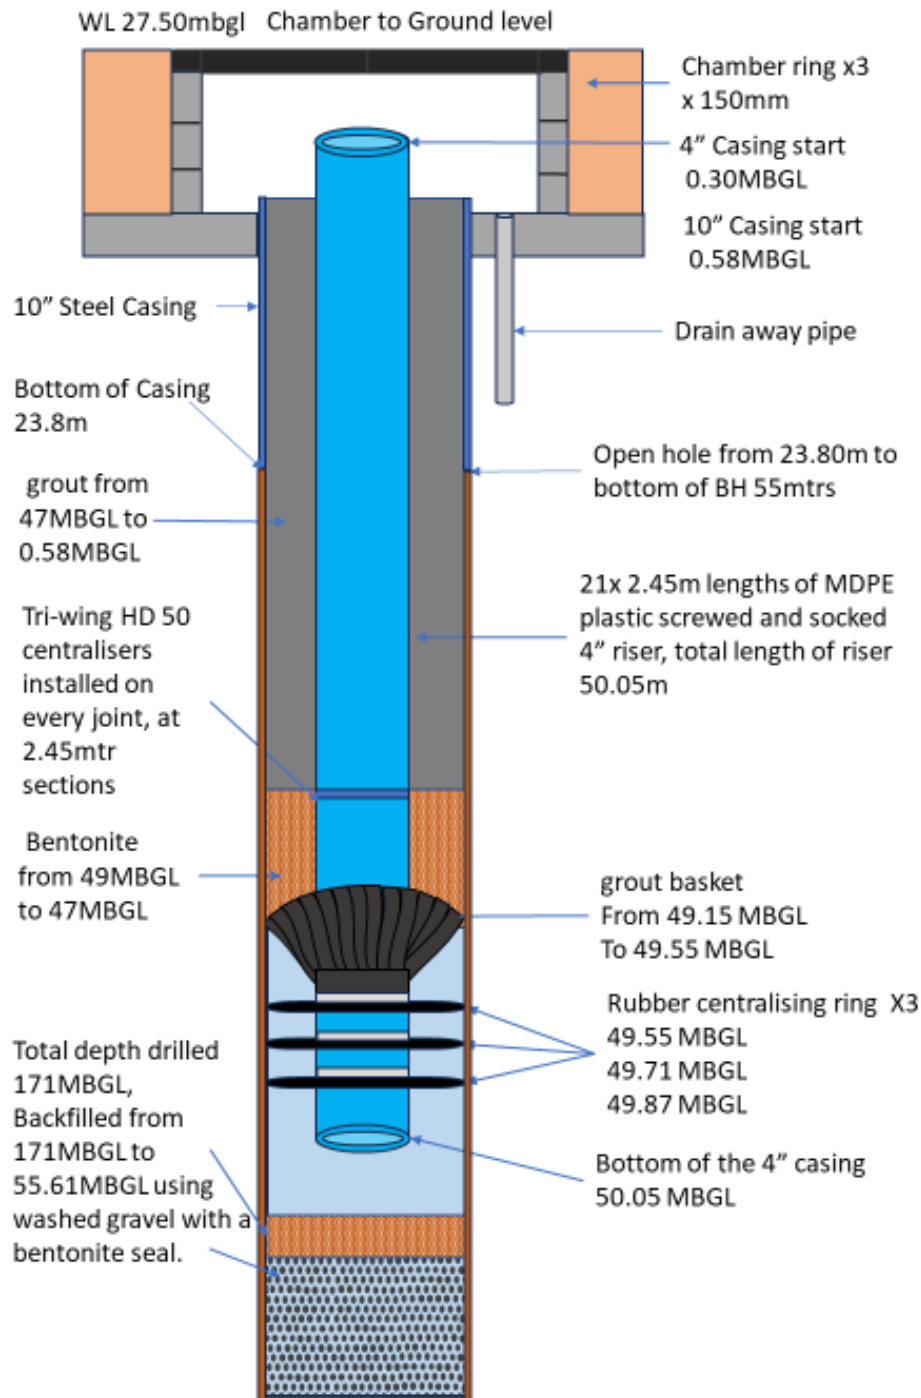
### Site A5, (Gateshead living lab) Borehole 2 (BH5b) diagram.

*GL is 0.30m above 4" casing.*

**Fig.3: Diagram of BH2 and casing installation performed in June-2023**

Before the installation of the 4" casing in BH2 the team backfilled the BH to a Depth of 55.61MBGL With Gravel and Bentonite pellets to create a good seal. The team then assembled and moved the grout basket in place over the BH location. From there the team lowered the first section of the casing in place in the BH, the section was clamped before the end of the pipe towards the join and from there the team loosened the lifting head and moved towards the next section. The team connected the next section of the 4" casing and moved it into place over the grout basket section, the 4" casing was then connected and the joint taped to prevent grout from leaking into the casing during the later grouting stage. After the joint was taped a HD50 Centraliser was then attached to the join, this process was then repeated till the 4" casing was installed to depth. Once the casing was installed to depth, the team introduced two bags of bentonite pellets down the annulus of the BH and casing, with the grout basket catching the bentonite pellets and ensuring a good seal. A small amount of grout was ran in, creating a good solid foundation ready for the remaining grout introduction which the team later introduced and completed.

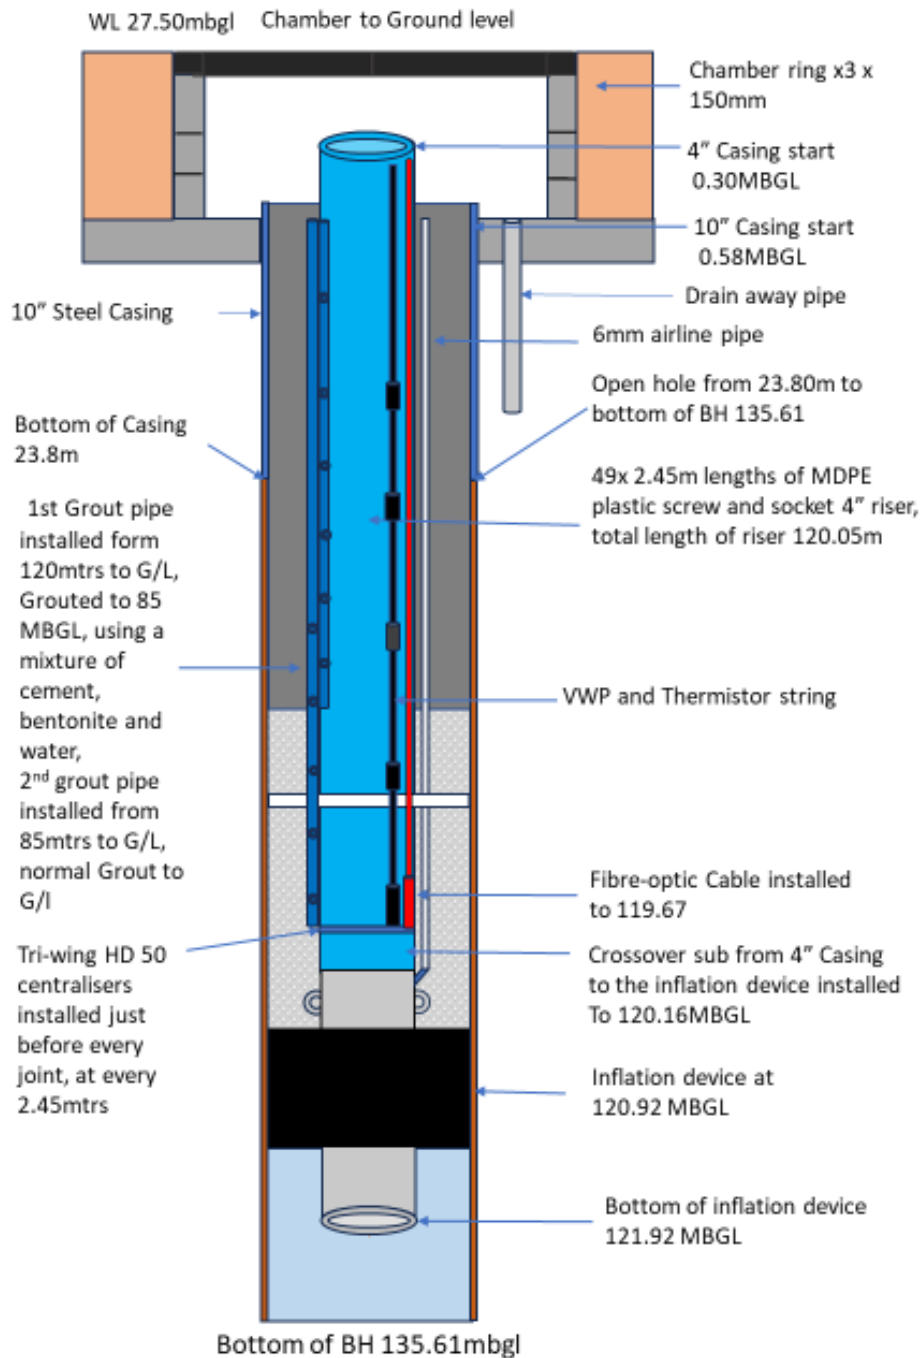
#### Site A5, (Gateshead living lab) Borehole 3 (BH5a) diagram.

*GL is 0.30m above the 4" casing.*

**Fig.4: Diagram of BH3 after the installation of the casing and cables, performed in June-2023**

Thermistor Depths	Piezo Depths	Fibre Optic Cable
49.16mbgl	11.56mbgl	119.67mbgl
119.67mbgl	27.29mbgl	
	79.70mbgl

Once the casing was installed to depth, the team introduced grout into the casing annulus from 120MBGL to 85MBGL, and then a special mixture of grout and bentonite with a ratio of (cement x 1, water x 2, bentonite x 0.36) was introduced from 85MBGL TO 10MBGL. The remaining 10m was topped up with normal grout.

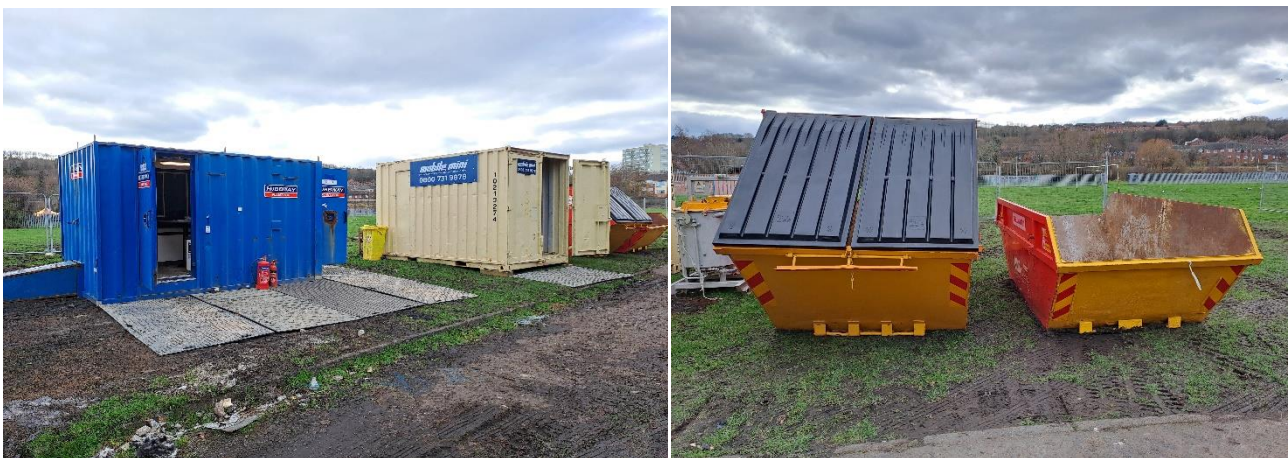
**Fig. 5: Image taken of the site-setup completed in February 2023**

The team employed good traffic control techniques while escorting waggon during peak school times and general hours, while keeping spatial awareness in mind the plant and equipment delivered on site was manoeuvred in place ready for the next phase of the plan.

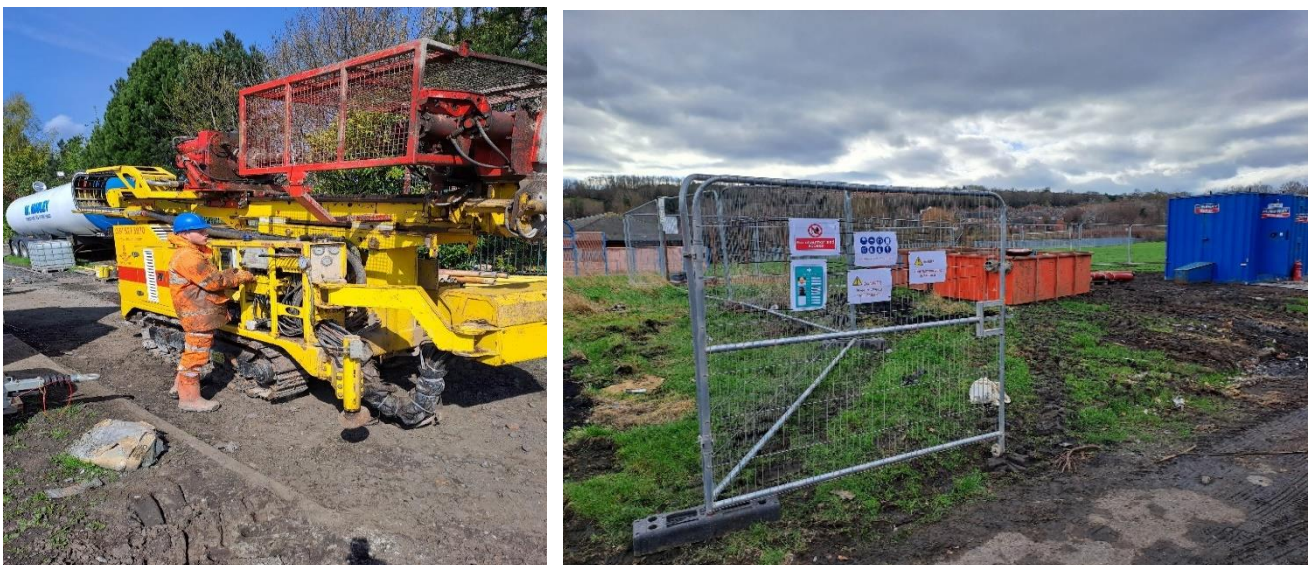
**Fig. 6: Image taken of the site-setup completed in February 2023**

Along with plant movement and equipment setup, the site was secured using Heras fencing, this reached around the entirety of site, safety signs were then attached to the fencing, the office was setup and more health and safety information was displayed and attached to the appropriate areas, muster points and gas detection zones where also marked out, and the team briefed.

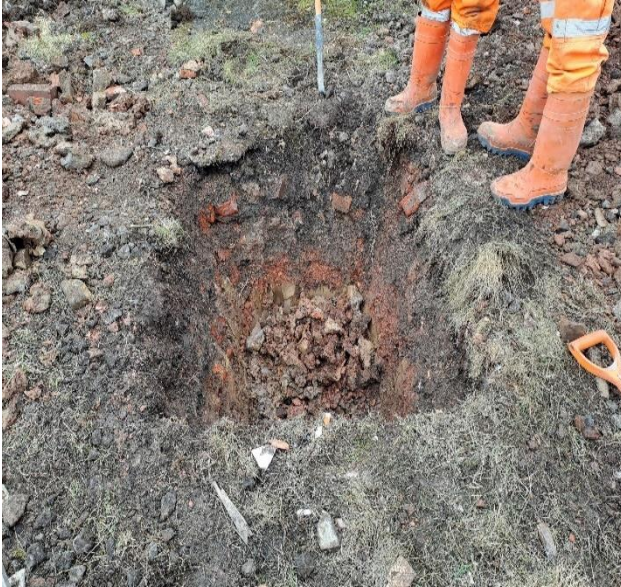
### **Trial Pit**

With the BH locations marked out and the area giving the all clear for buried services, the team will begin marking out the trial pit, this entails, measuring the trial pit to the dimensions of 1.2mtrs X 1.2mtrs X 1.2mtrs. Once measured out the team will, using the aid of the CAT and Genny, Breaker pack and insulated digging tools, begin to dig out the trial pit to the previously mentioned dimensions, checking for any buried services not found by the GPR Survey. The process was repeated throughout the job for the three trial pits, the pit serves two functions,

**Function 1:** to serve as the base for the later chamber installation,

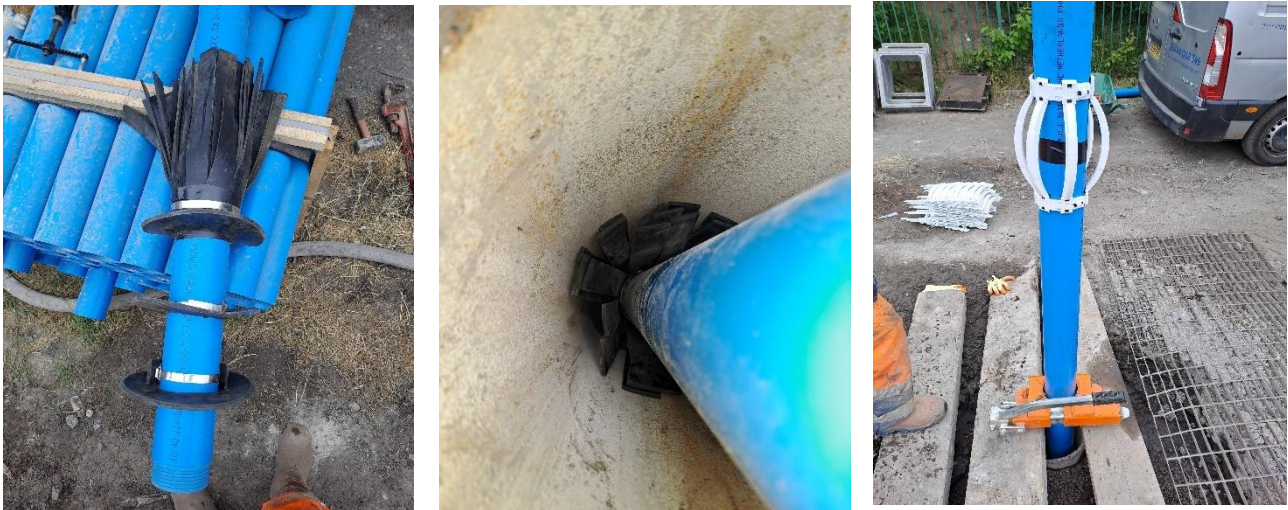
***Fig. 8: Image taken of the installation of BH2 completed June-2023***

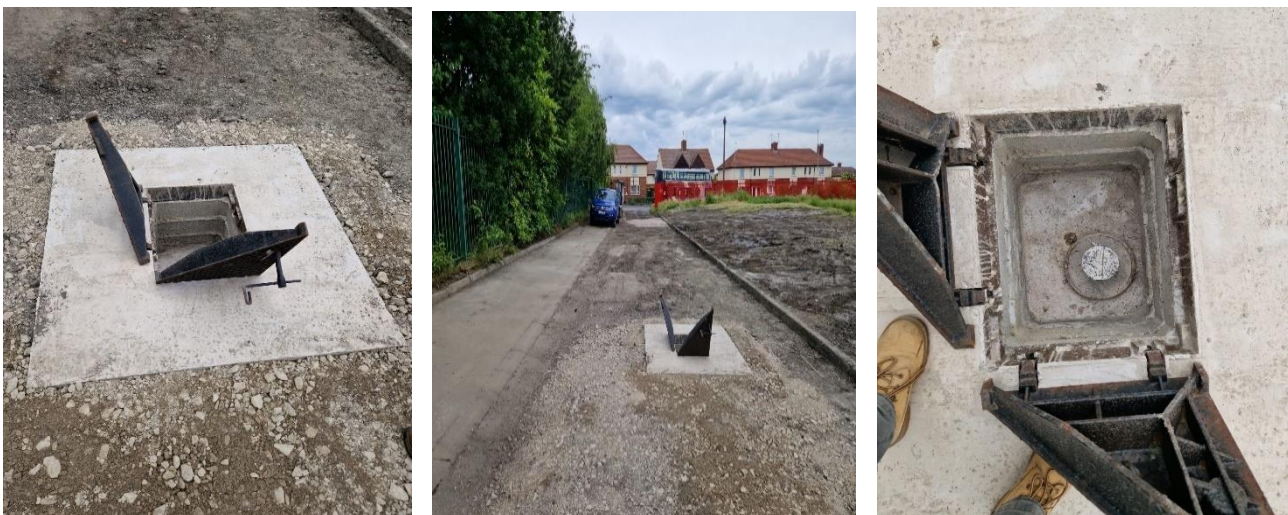
The installation of the chamber rings and completion of the chamber began with the team extending the trial pit outwards, giving the team room to get in and cut the casing down. The team completed the shuttering around the base of the chamber making sure that the pit was dug to 80cm deep and backfilling the outer edges of the trial pit with the removed debris from the pit extension measuring the top of the shuttering so that it was 60cm exact from G/L.

Once the shuttering was done, the team mixed up concrete and poured it into the shuttering, smoothing the surface and measuring levels to maintain the 60cm from G/L to the top of the shuttering. From this point the team allowed the concrete to harden. Once the concrete had gone off the team marked out the 10" and 4" casing, cutting both to the correct depths before the team moved the chamber rings into position using a mortar mixture to fix the rings to the base of the concrete plinth, ensuring the chamber rings were level and the correct height from G/L. The exterior of the trial pit was then filled in with concrete to just below the top of the chamber rings. Once set off the team installed the chamber lid to the top of the chamber with mortar and concrete around the whole lid so that the top of the lid is flush to G/L.

***Fig. 9: Image taken of the chamber before and after photos, completed in June-2023***

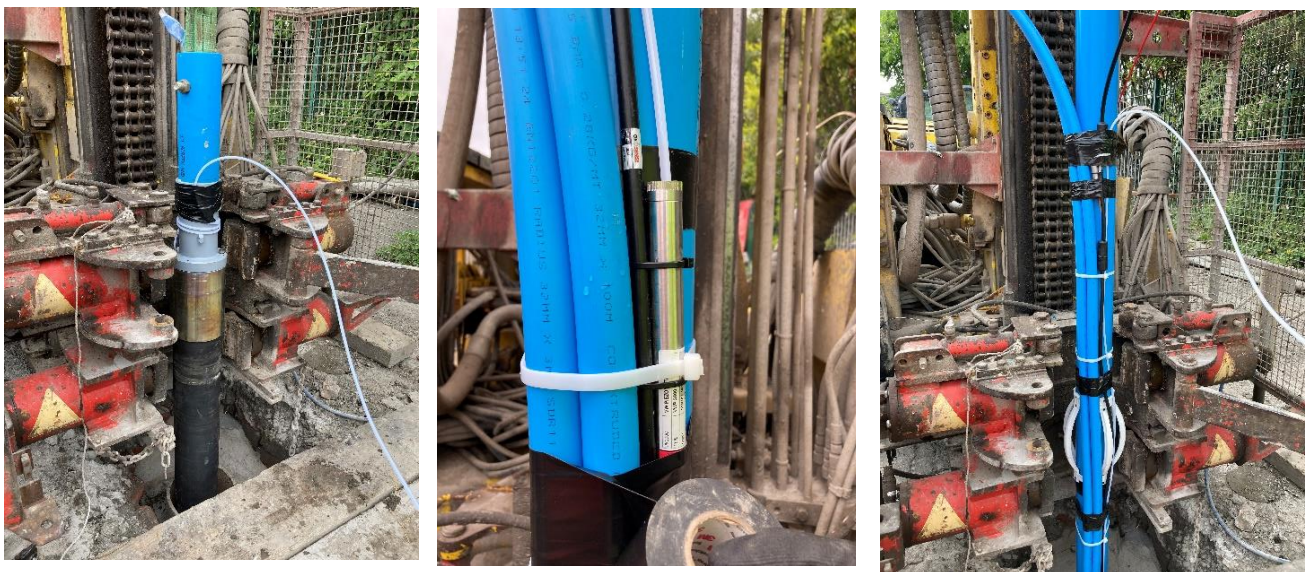
**Fig. 10: Image acquired during the installation of the 4" casing and adjoining cables completed in June-2023**

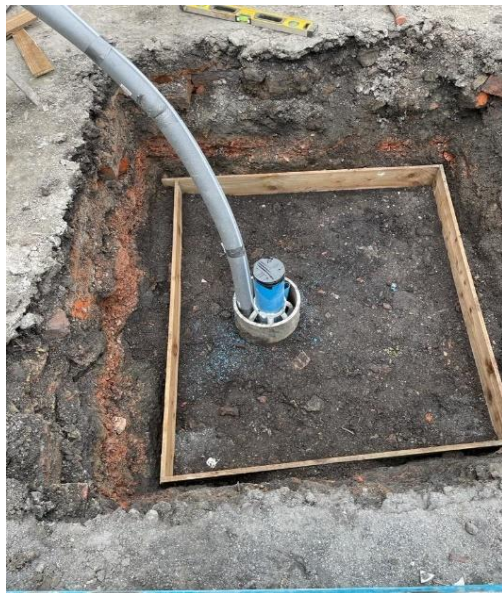
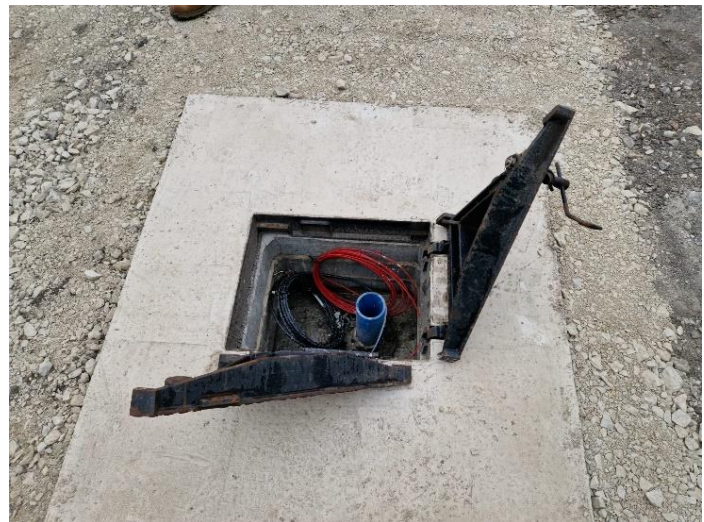
The installation of the chamber rings and completion of the chamber began with the team extending the trial pit outwards, giving the team room to get in and cut the casing down, the team completed the shuttering around the base of the chamber making sure that the pit was dug to 80cm deep and backfilling the outer edges of the trial pit with the removed debris from the pit extension measuring the top of the shuttering so that it was 60cm exact from G/L.

Once the shuttering was done the team mixed up concrete and poured it into the shuttering, smoothing the surface and measuring to maintain the 60cm from G/L to the top of the shuttering, from this point the team allowed the concrete to harden. Once the concrete had gone off, the team marked out the 10" and 4" casing, cutting both to the correct depths before the team moved the chamber rings into position using a mortar mixture to fix the rings to the base of the concrete plinth, ensuring the chamber rings are level and the correct height from G/L. The exterior of the trial pit was then filled in with concrete to just below the top of the chamber rings. Once set off the team installed the chamber lid to the top of the chamber with mortar and concrete around the whole lid so that the top of the lid is flush to G/L.

***Fig. 11: Image taken of the chamber before and after photos, completed in June-2023***

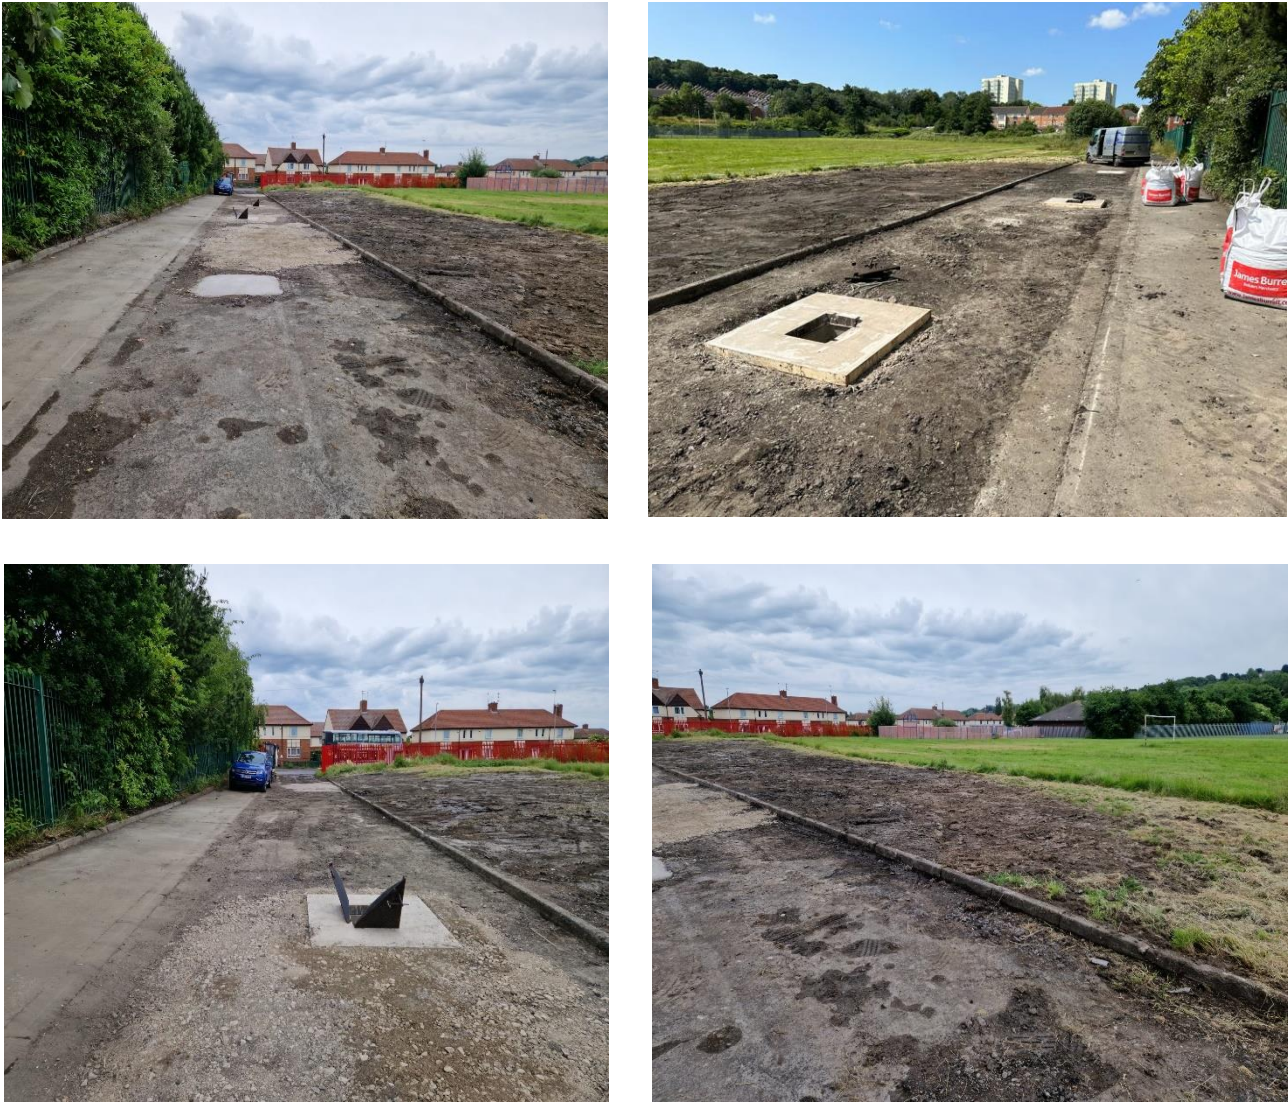
**Fig. 12: Images acquired after the re-instatement operations carried out in June-2023**

Due to the small site footprint, the state of the ground and the plant being utilised on site, the condition of the ground had been compromised. The wet and rainy conditions throughout the project contributed towards the state of the ground on site, with the project moving into the warmer months, the condition of site improved to the point that a final re-instatement date could be planned and carried out.

With the aid of a mini-digger and telehandler, the team cleaned the roadway, path and the field section, and smoothed and filled in any holes and uneven patches of ground. They used either the pre-existing ground or bags of gravel / ballast to achieve the ideal ground condition. The team used ballast to fill in the holes on the roadway whilst the soil was used to fill in the grass way.

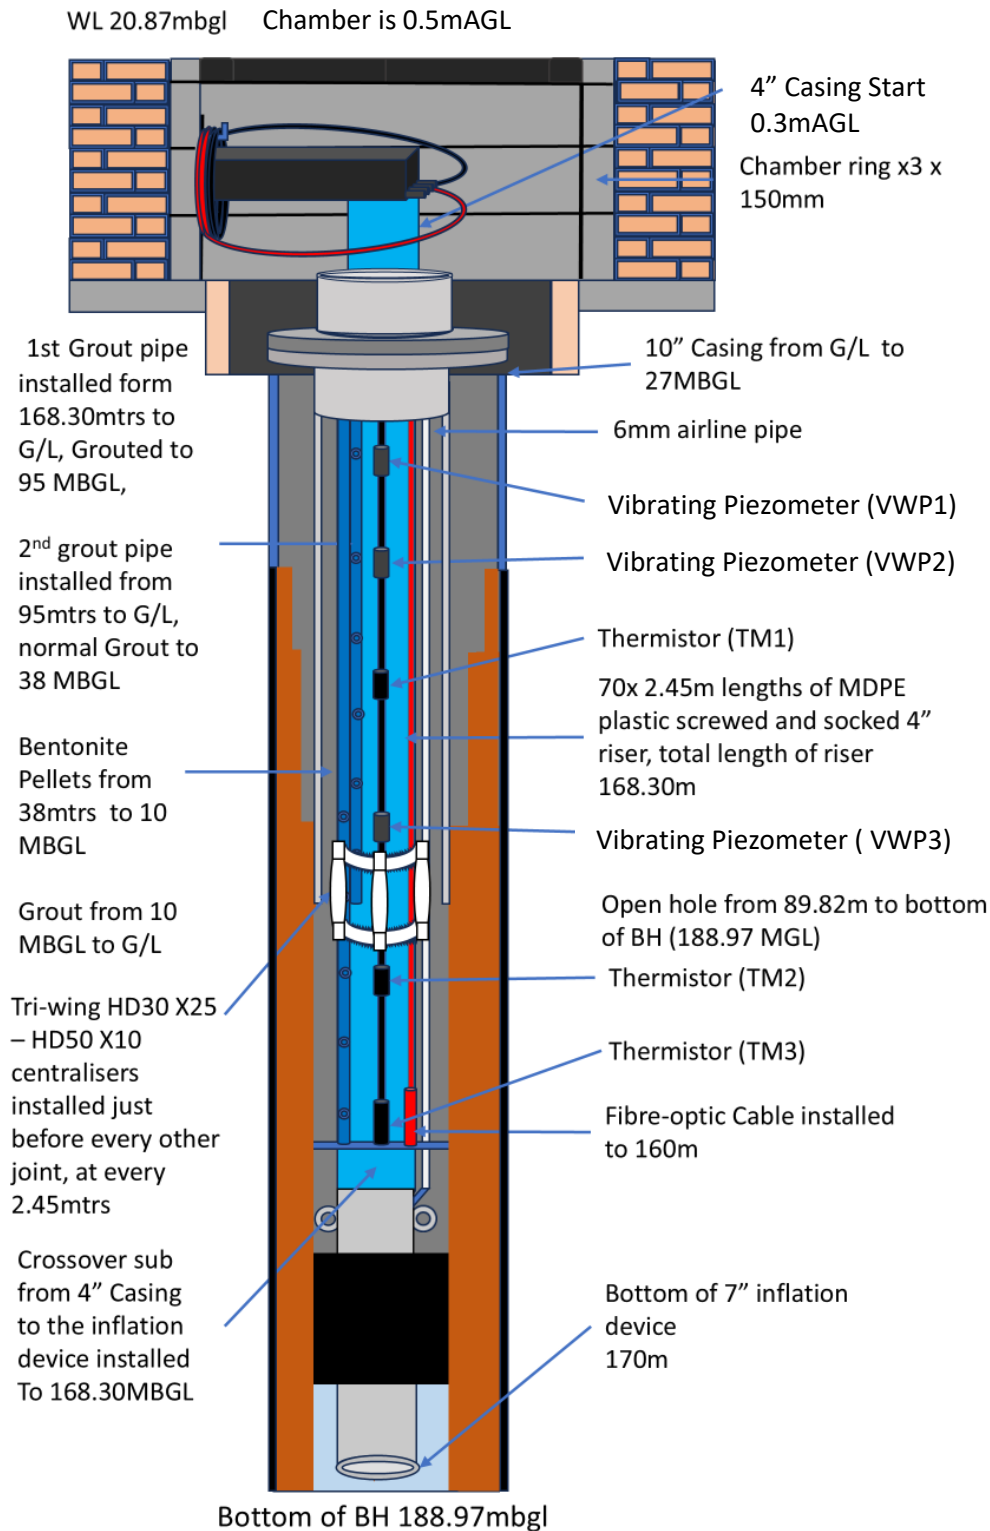
### Site A4, Gateshead Stadium Hutton, Borehole BH4a-01A Diagram

*Top of Plastic Casing is 0.30m above G/L*

**Fig. 2: Diagram of BH4a-01A Hutton**

<b>Thermistor Depths</b>	<b>Piezo Depths</b>	<b>Fibre Optic Cable</b>
<b>47.86mbgl</b>	<b>10.27mbgl</b>	<b>160mbgl</b>
<b>120.45mbgl</b>	<b>30.28mbgl</b>	
<b>160mbgl</b>	<b>80.22mbgl</b>

Once the casing was installed to depth, the team introduced grout into the casing annulus from 160MBGL to 95MBGL, and then grout was introduced from 95MBGL TO 10MBGL. The remaining 10m was topped up with normal grout.

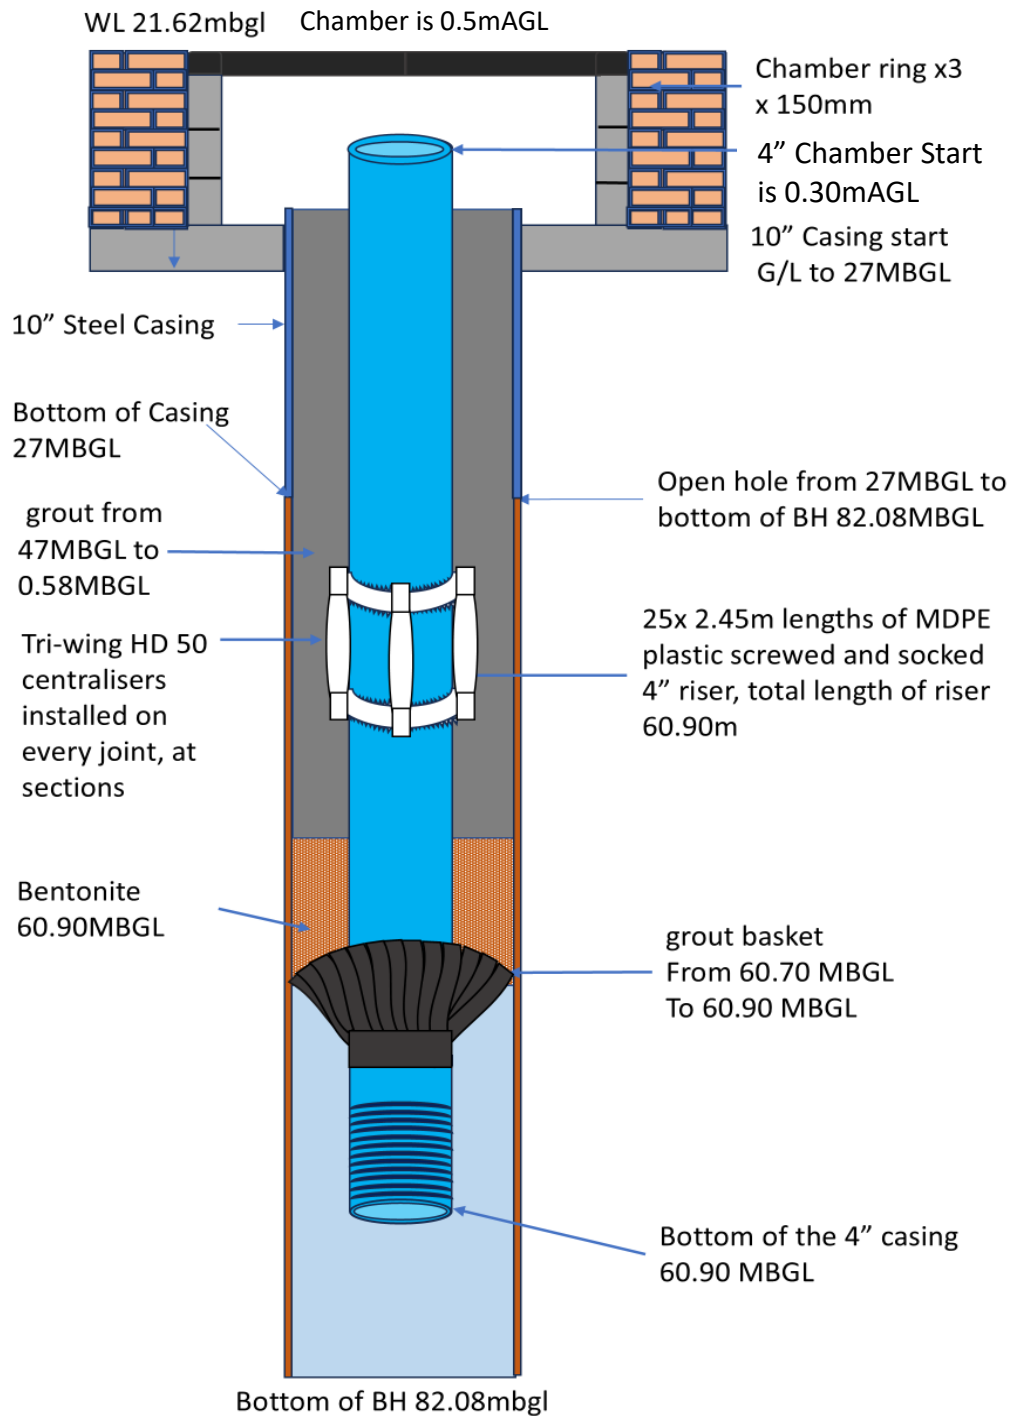
### Site A4, (Gateshead Stadium High Main BH4b-01 Diagram

*GL is 0.30m above 4" casing.*

**Fig.3: Diagram of BH4b-01 Stadium High Main**

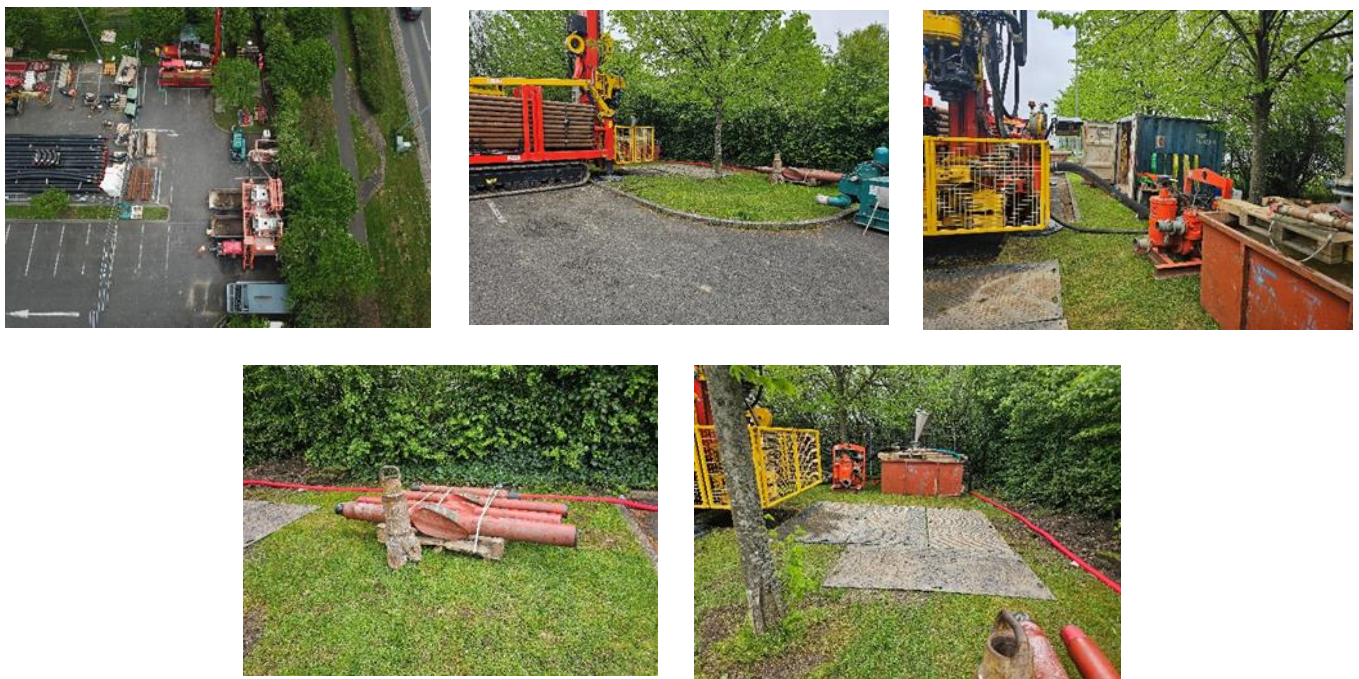
***Fig. 4: Image taken of the site- setup***

Safety and informational signs were secured at appropriate sections of the fencing. Additional H&S (Health and Safety) documentation along with the Rams and job program were located in the welfare unit.

Along with plant movement and equipment setup, the site was secured using Heras fencing. This enclosed the entirety of the site, with safety signs attached to the fencing at appropriate intervals. A site office was set up, which contained the health and safety and construction information. This information detailed the muster points and gas detection zones throughout site, as well as the induction point to access site.

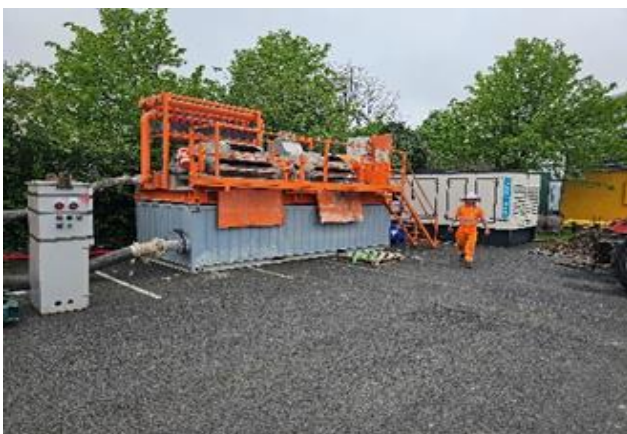
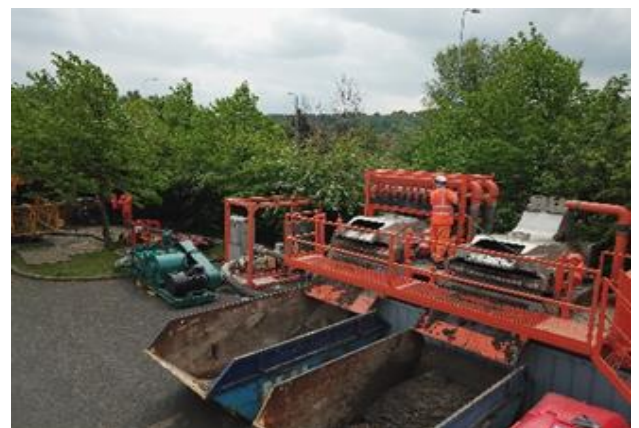
The team mixed and weighed the correct amount of bentonite and Polymer to water ratio. The reason these substances were added to the flush is to aid in drilling operations and, throughout the job, flush can maintain the structural integrity of the borehole walls. This also allows for debris produced by the drilling process to clear the hole and rise to the surface to be collected in the trial pit. This is then transferred through the mud treatment system. Water for site was supplied via a hydrant on site.

Fig. 5: Image taken of the mud treatment and shaker

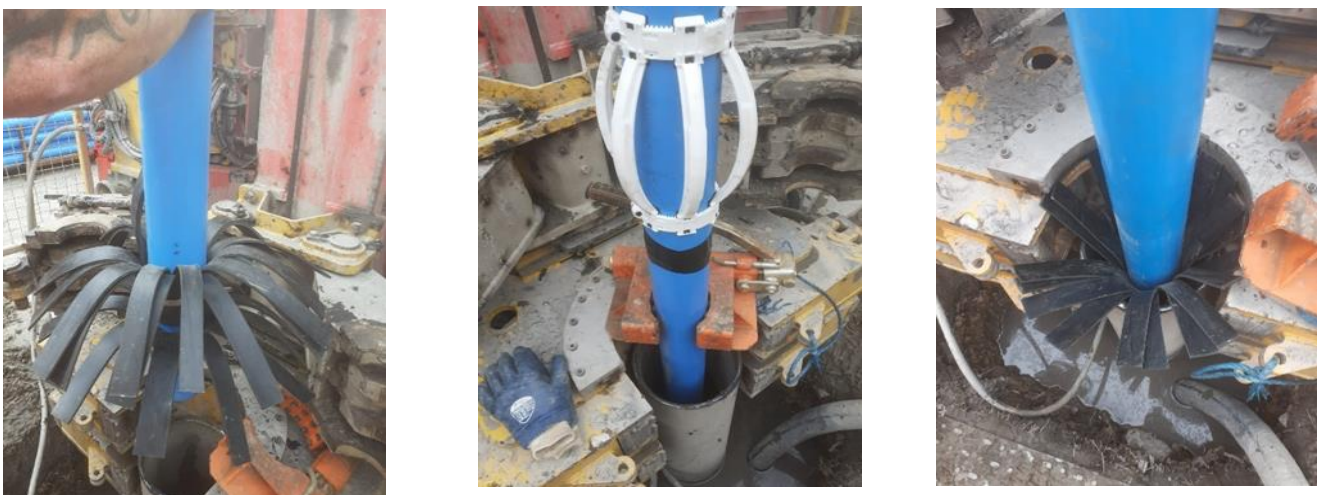
The team assembled and moved the grout basket in place over the BH location. From there the team lowered the first section of the casing in place over the BH, which was clamped before the end of the join. From there the team loosened the lifting head and moved towards the next section. The team connected the next section of the 4" casing and moved it into place over the grout basket section. The 4" casing was then connected and the joint taped to prevent grout from leaking into the casing during the later grouting stage. After the joint was taped a HD50 Centraliser was then attached to the join, this process was then repeated till the 4" casing was installed to depth. Once the casing was installed to depth, the team introduced two bags of bentonite pellets down the annulus of the BH and casing, with the grout basket catching the bentonite pellets and ensuring a good seal. A small amount of grout was ran in, creating a good solid foundation ready for the remaining grout which the team later introduced and completed.

**Fig. 6: Image taken of the installation of BH4b-01 Stadium High Main**

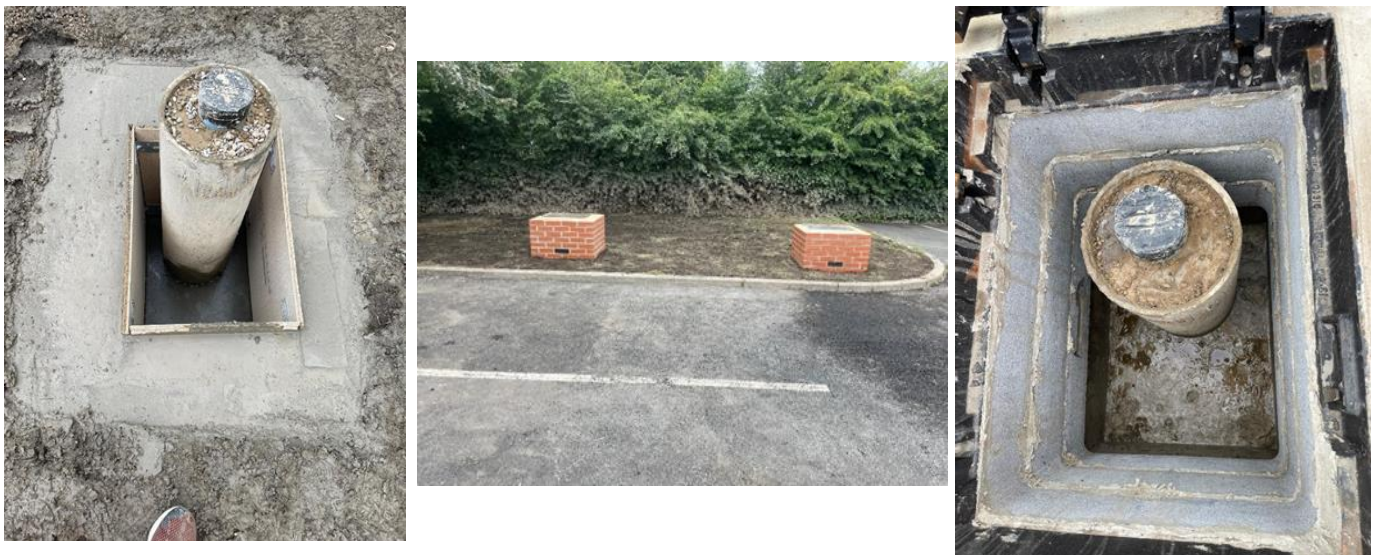
Once the shuttering was done, the team mixed up concrete and poured it into the trial pit surrounding the shuttering, smoothing the surface and measuring levels to maintain an even finish to G/L. From this point the team allowed the concrete to harden. Once the concrete had gone off the team marked out the 10" and 4" casing, cutting both to the correct depths, before the team moved the chamber rings into position using a mortar mixture to fix the rings to the base of the concrete plinth. They ensured the chamber rings were level and the correct height from G/L. Once set off the team installed the lid to the top of the chamber with mortar and concrete. This was installed around the whole lid so that the top of the lid is flush to the surface of the chamber.

From there the team built up the exterior of the chamber using bricks to achieve a professional finish and to secure the chamber.

***Fig. 7: Image taken of the chamber before and after photos***

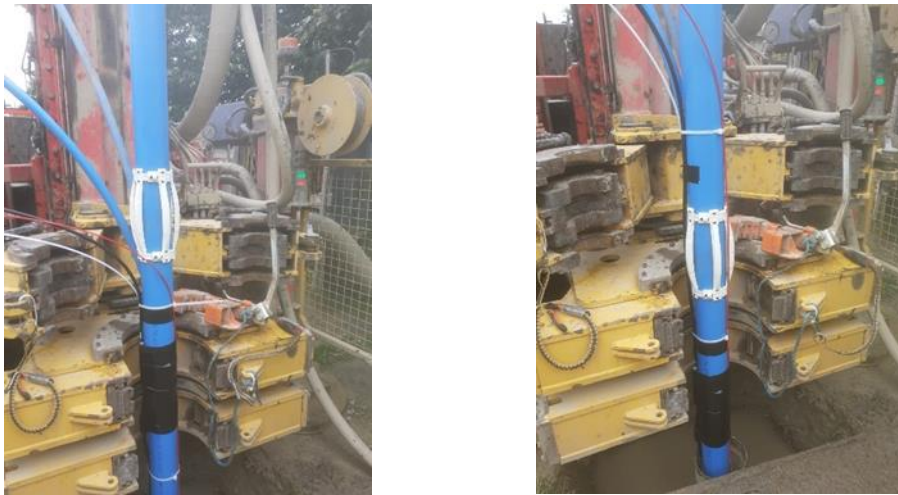
***Fig. 8: Image taken of the installation of BH4b-01 Stadium Hutton***

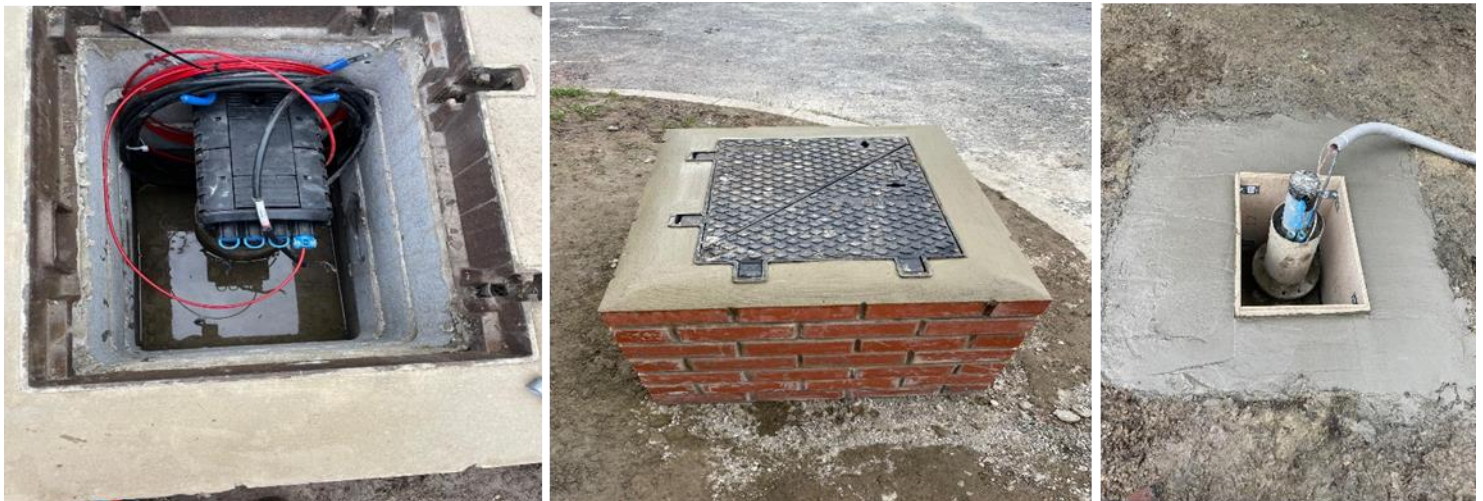
Once the shuttering was done, the team mixed up concrete and poured it into the trial pit surrounding the shuttering, smoothing the surface and measuring levels to maintain an even finish to G/L. From this point the team allowed the concrete to harden. Once the concrete had gone off the team marked out the 10" and 4" casing, cutting both to the correct depths before the team moved the chamber rings into position using a mortar mixture to fix the rings to the base of the concrete plinth. This ensured the chamber rings were level and the correct height from G/L. Once set off the team installed the lid to the top of the chamber with mortar and concrete. This was installed around the whole lid so that the top of the lid is flush to the surface of the chamber.

From there the team built up the exterior of the chamber using bricks to achieve a professional finish and to secure the chamber.

***Fig.9: Image taken of the chamber before and after photos,***
