Mining
Remediation
Authority

User Guide

Gateshead mine water heat living laboratory
dataset

May 2025

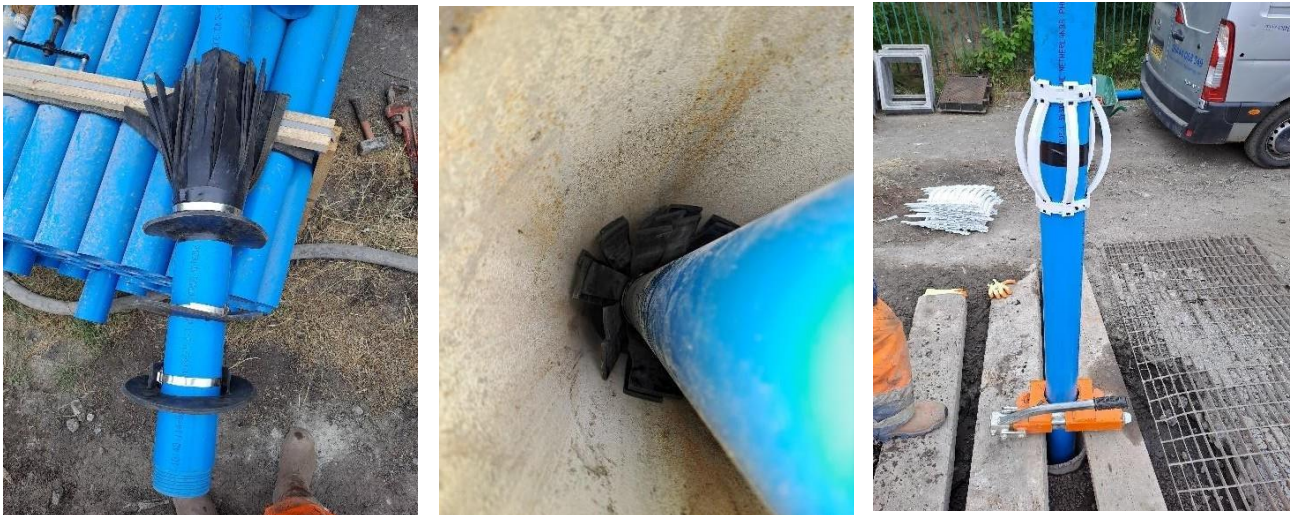
Fig. 8: Image taken of the installation of BH2 completed June-2023

Before the installation of the 4" casing in BH2 the team backfilled the BH to a Depth of 55.61MBGL With Gravel and Bentonite pellets to create a good seal. The team then assembled and moved the grout basket in place over the BH location. From there the team lowered the first section of the casing in place in the BH, the section was clamped before the end of the pipe towards the join and from there the team loosened the lifting head and moved towards the next section. The team connected the next section of the 4" casing and moved it into place over the grout basket section, the 4" casing was then connected and the joint taped to prevent grout from leaking into the casing during the later grouting stage. After the joint was taped a HD50 Centraliser was then attached to the join, this process was then repeated till the 4" casing was installed to depth. Once the casing was installed to depth, the team introduced two bags of bentonite pellets down the annulus of the BH and casing, with the grout basket catching the bentonite pellets and ensuring a good seal. A small amount of grout was ran in, creating a good solid foundation ready for the remaining grout introduction which the team later introduced and completed.

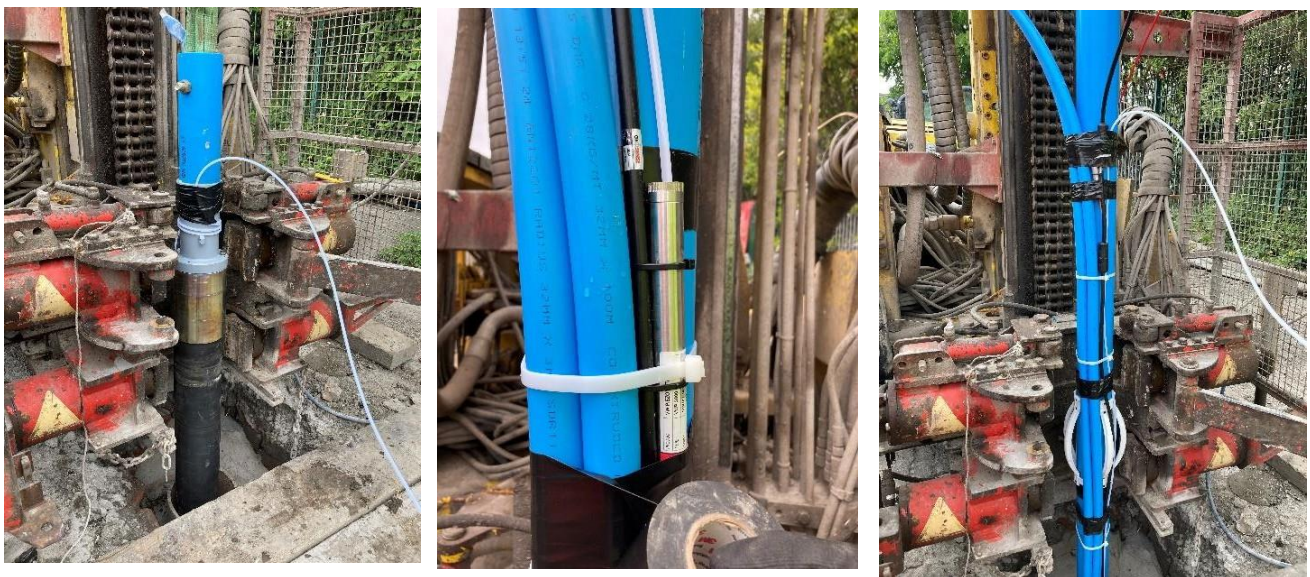
Once the casing was installed to depth, the team introduced grout into the casing annulus from 120MBGL to 85MBGL, and then a special mixture of grout and bentonite with a ratio of (cement x 1, water x 2, bentonite x 0.36) was introduced from 85MBGL TO 10MBGL. The remaining 10m was topped up with normal grout.

Fig. 10: Image acquired during the installation of the 4" casing and adjoining cables completed in June-2023

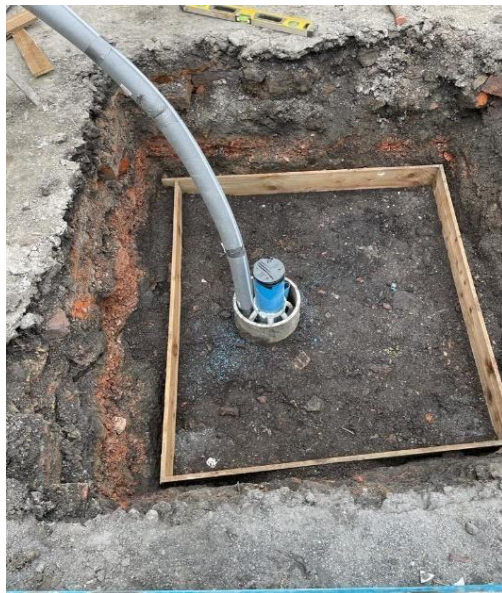
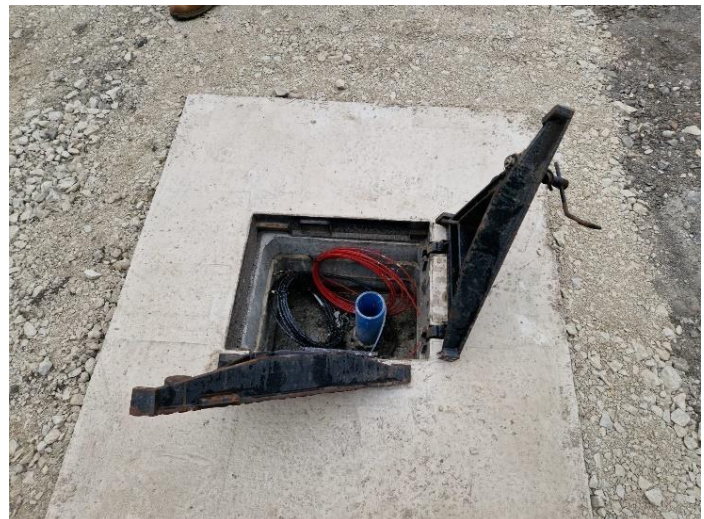
The installation of the chamber rings and completion of the chamber began with the team extending the trial pit outwards, giving the team room to get in and cut the casing down, the team completed the shuttering around the base of the chamber making sure that the pit was dug to 80cm deep and backfilling the outer edges of the trial pit with the removed debris from the pit extension measuring the top of the shuttering so that it was 60cm exact from G/L.

Once the shuttering was done the team mixed up concrete and poured it into the shuttering, smoothing the surface and measuring to maintain the 60cm from G/L to the top of the shuttering, from this point the team allowed the concrete to harden. Once the concrete had gone off, the team marked out the 10" and 4" casing, cutting both to the correct depths before the team moved the chamber rings into position using a mortar mixture to fix the rings to the base of the concrete plinth, ensuring the chamber rings are level and the correct height from G/L. The exterior of the trial pit was then filled in with concrete to just below the top of the chamber rings. Once set off the team installed the chamber lid to the top of the chamber with mortar and concrete around the whole lid so that the top of the lid is flush to G/L.

Fig. 11: Image taken of the chamber before and after photos, completed in June-2023

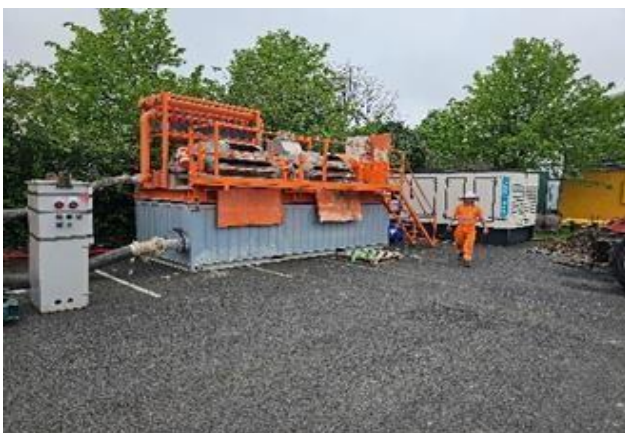
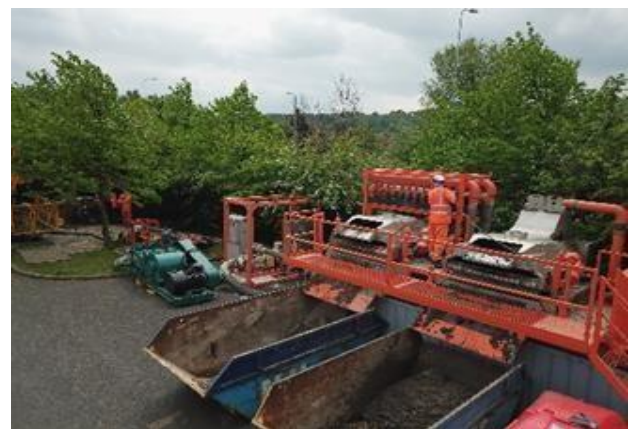
The team mixed and weighed the correct amount of bentonite and Polymer to water ratio. The reason these substances were added to the flush is to aid in drilling operations and, throughout the job, flush can maintain the structural integrity of the borehole walls. This also allows for debris produced by the drilling process to clear the hole and rise to the surface to be collected in the trial pit. This is then transferred through the mud treatment system. Water for site was supplied via a hydrant on site.

Fig. 5: Image taken of the mud treatment and shaker

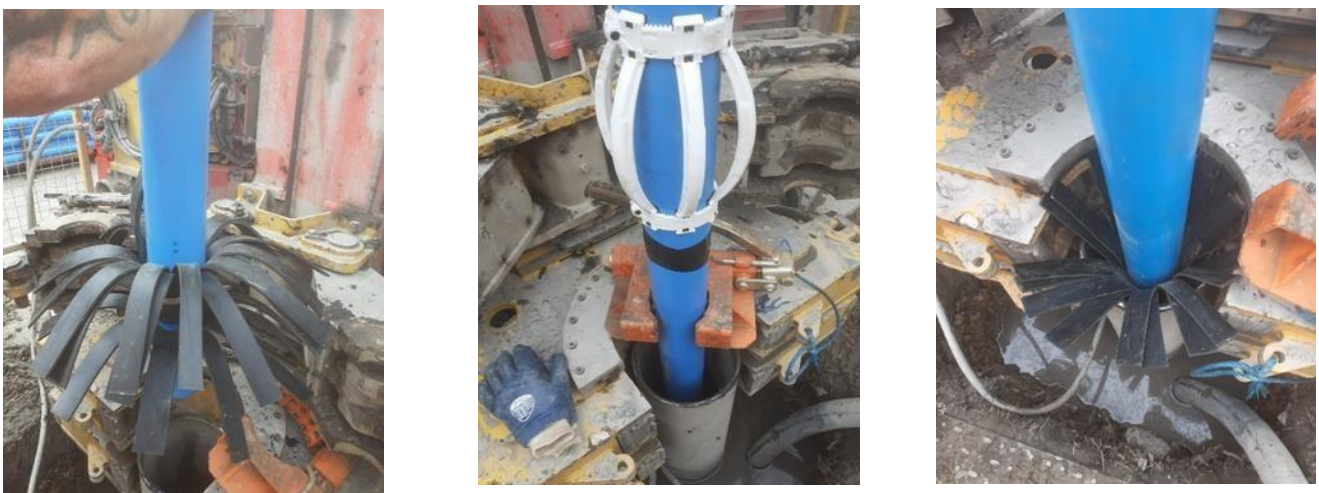
The team assembled and moved the grout basket in place over the BH location. From there the team lowered the first section of the casing in place over the BH, which was clamped before the end of the join. From there the team loosened the lifting head and moved towards the next section. The team connected the next section of the 4" casing and moved it into place over the grout basket section. The 4" casing was then connected and the joint taped to prevent grout from leaking into the casing during the later grouting stage. After the joint was taped a HD50 Centraliser was then attached to the join, this process was then repeated till the 4" casing was installed to depth. Once the casing was installed to depth, the team introduced two bags of bentonite pellets down the annulus of the BH and casing, with the grout basket catching the bentonite pellets and ensuring a good seal. A small amount of grout was ran in, creating a good solid foundation ready for the remaining grout which the team later introduced and completed.

Fig. 6: Image taken of the installation of BH4b-01 Stadium High Main

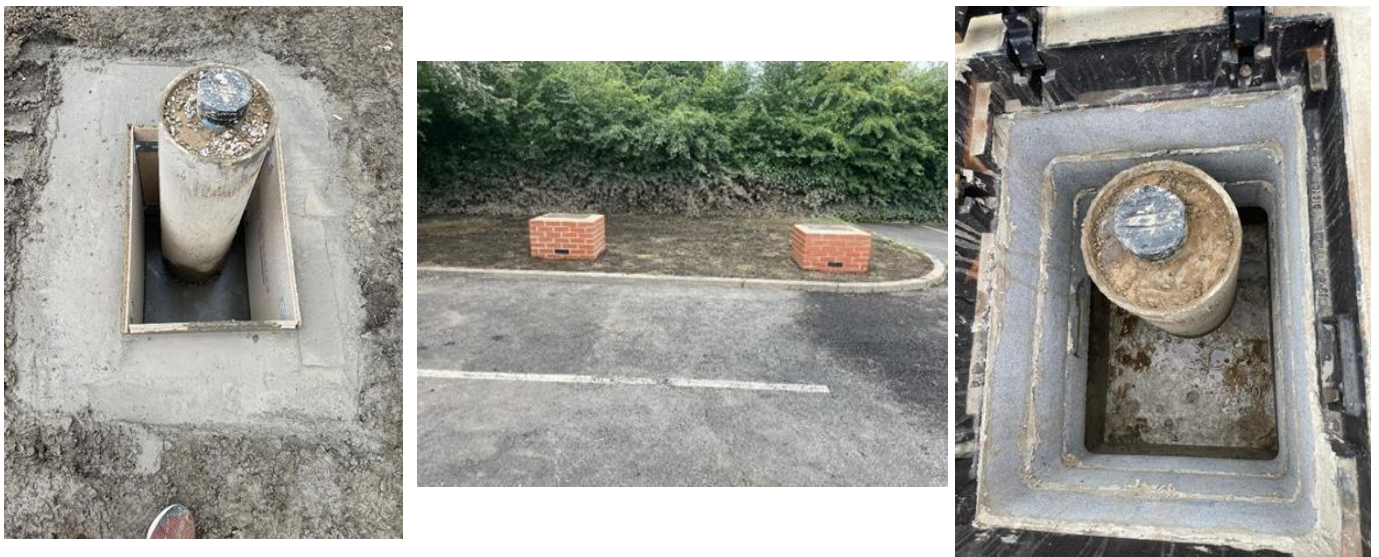
Once the shuttering was done, the team mixed up concrete and poured it into the trial pit surrounding the shuttering, smoothing the surface and measuring levels to maintain an even finish to G/L. From this point the team allowed the concrete to harden. Once the concrete had gone off the team marked out the 10" and 4" casing, cutting both to the correct depths, before the team moved the chamber rings into position using a mortar mixture to fix the rings to the base of the concrete plinth. They ensured the chamber rings were level and the correct height from G/L. Once set off the team installed the lid to the top of the chamber with mortar and concrete. This was installed around the whole lid so that the top of the lid is flush to the surface of the chamber.

From there the team built up the exterior of the chamber using bricks to achieve a professional finish and to secure the chamber.

Fig. 7: Image taken of the chamber before and after photos

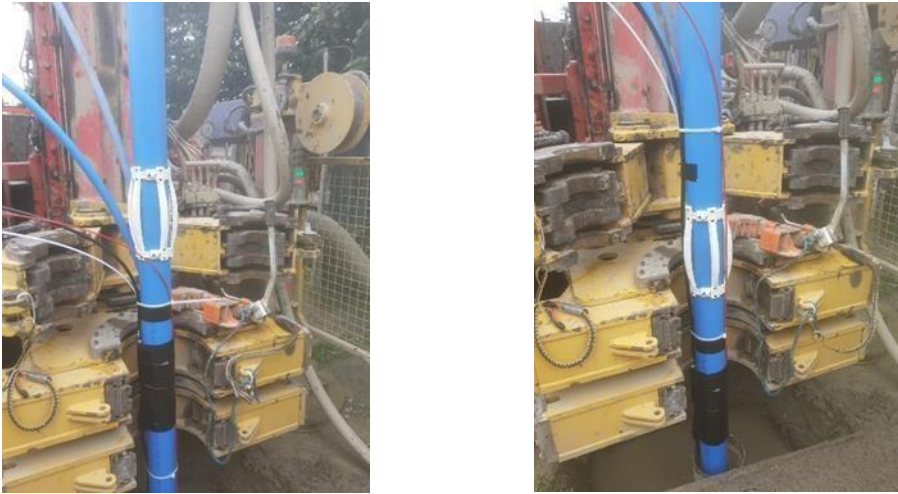
Once the casing was installed to depth, the team introduced grout into the casing annulus from 160MBGL to 95MBGL, and then grout was introduced from 95MBGL TO 10MBGL. The remaining 10m was topped up with normal grout.

Fig. 8: Image taken of the installation of BH4b-01 Stadium Hutton

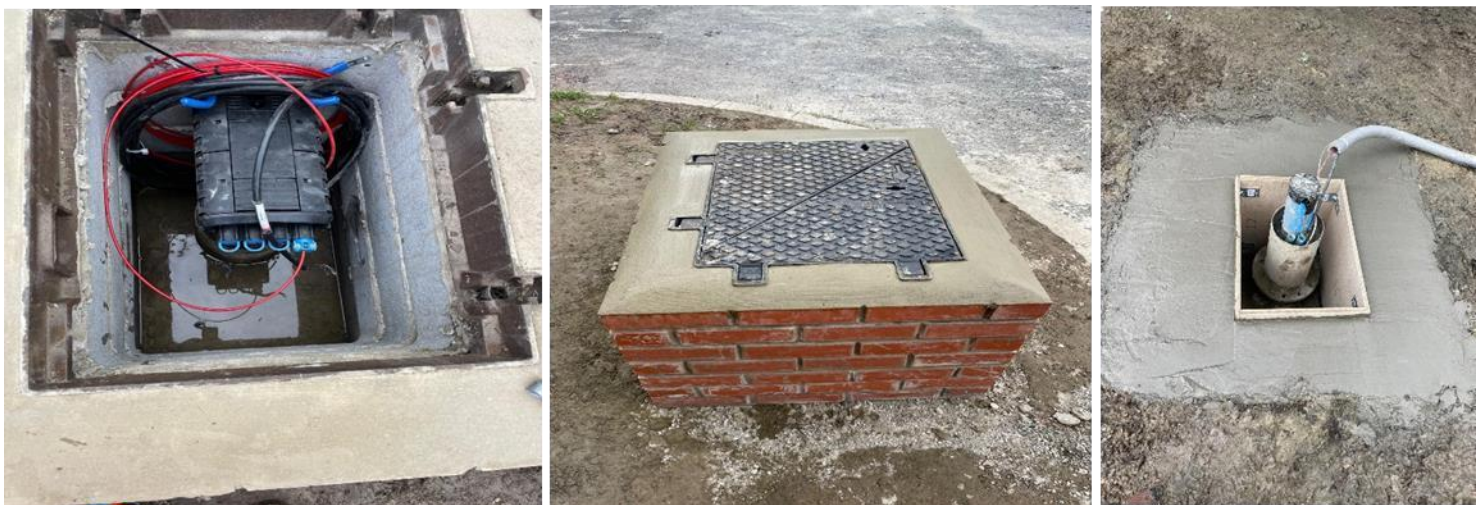
Once the shuttering was done, the team mixed up concrete and poured it into the trial pit surrounding the shuttering, smoothing the surface and measuring levels to maintain an even finish to G/L. From this point the team allowed the concrete to harden. Once the concrete had gone off the team marked out the 10" and 4" casing, cutting both to the correct depths before the team moved the chamber rings into position using a mortar mixture to fix the rings to the base of the concrete plinth. This ensured the chamber rings were level and the correct height from G/L. Once set off the team installed the lid to the top of the chamber with mortar and concrete. This was installed around the whole lid so that the top of the lid is flush to the surface of the chamber.

From there the team built up the exterior of the chamber using bricks to achieve a professional finish and to secure the chamber.

Fig.9: Image taken of the chamber before and after photos,
